SERVICE SHOP NOTES

LIMA[®] MAC SELF VOLTAGE REGULATED GENERATORS

Troubleshooting Tips

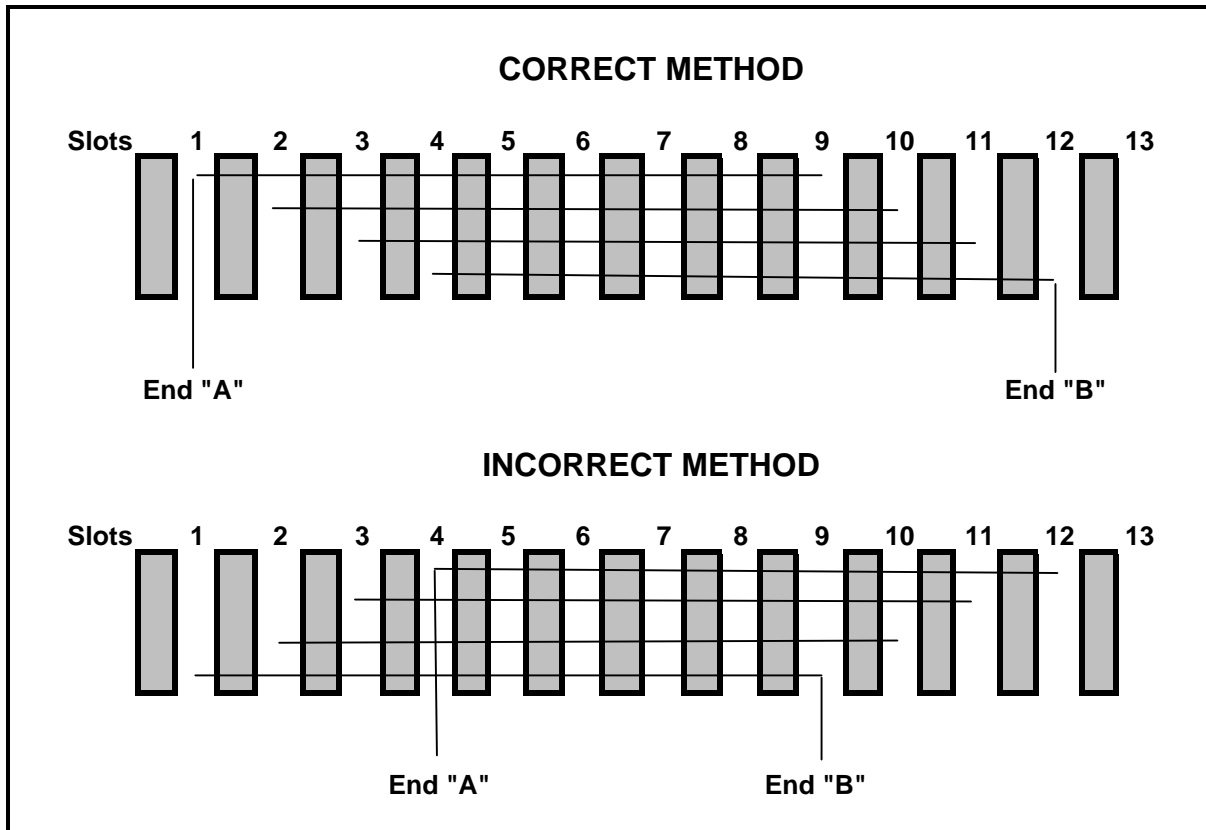
DIAGRAM 1

Viewing the "Coil Connect" circle as shown, the coils are inserted in a counter-clockwise (CCW) direction. The "A" side is inserted first in a CCW direction. Coil end "A" is in the last slot to be inserted. The "B" side is then inserted. After insertion, coil ends "A" & "B" must be at the outer edges of the coil group. If they are inserted to the inside of the coil group, the unit may have low voltage under load. See Diagram 1. Inserting the coils in a clockwise direction is acceptable if done consistently. It may result in a reversed phase sequence though.

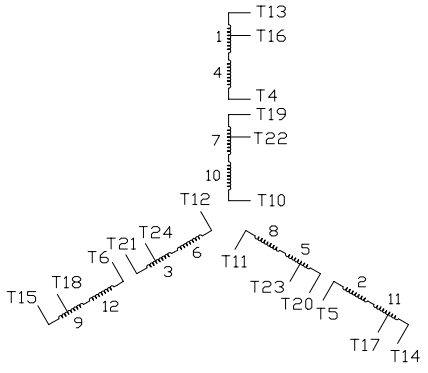
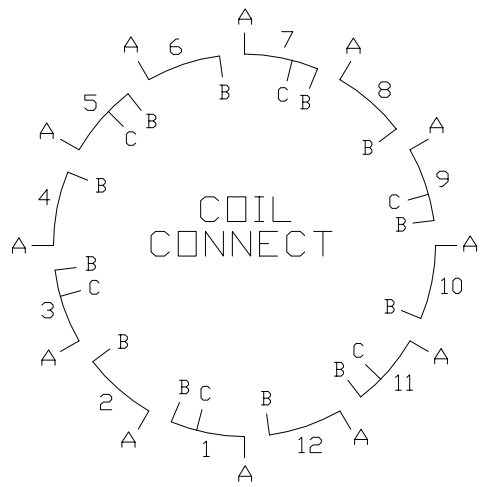
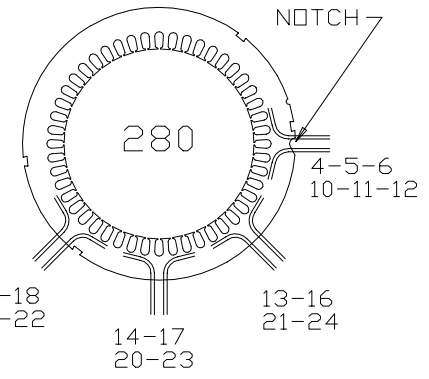
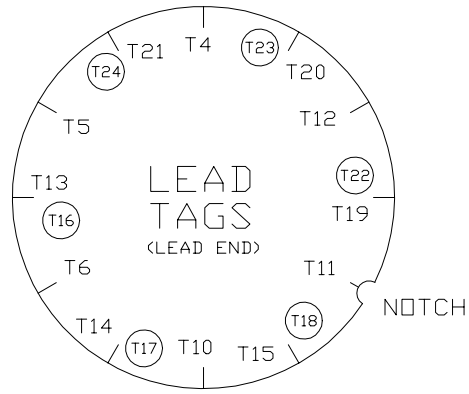
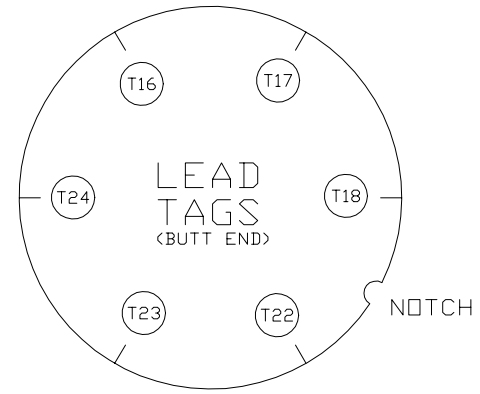
12 Lead Generator Procedure, Reference Connection Diagram 14002-31:

Check resistance from T13-T4. It should be some small number. Then check from T4-T16. It should be a little bit smaller or about the same if not easily detectable. Then check T13-T16. This should be almost zero. If T16-T4 is almost zero, swap the lead numbers from T13 and T16. Repeat the procedure for the other six sets of coils and leads. If the reading from T4-T16 is nearly equal to T4-T13, the internal connection between coil one and four is wrong. It must be broken and corrected. Repeat the procedure for the other six sets of coils and leads.

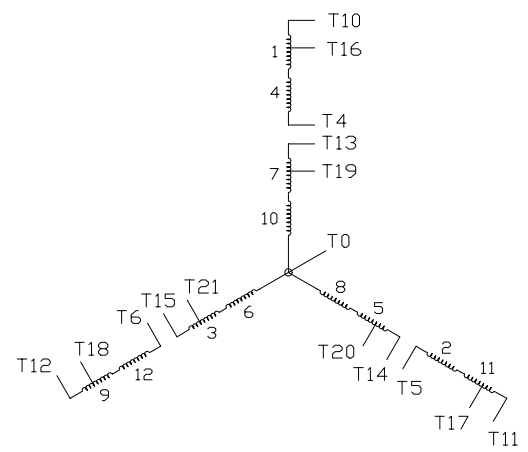
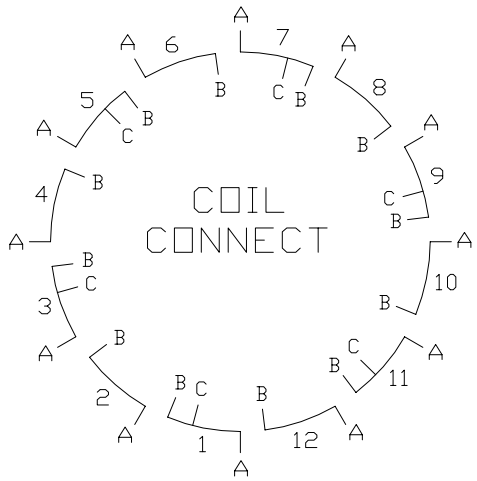
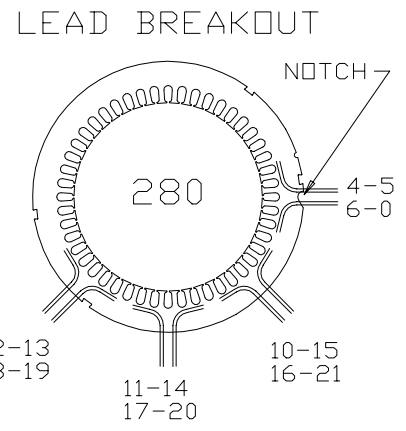
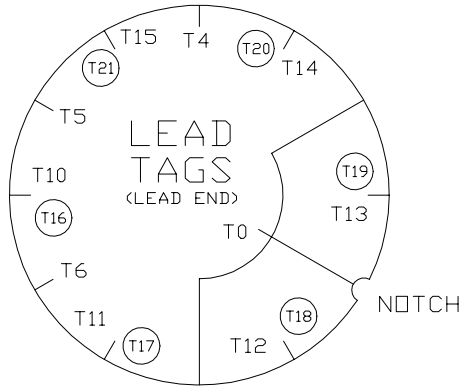
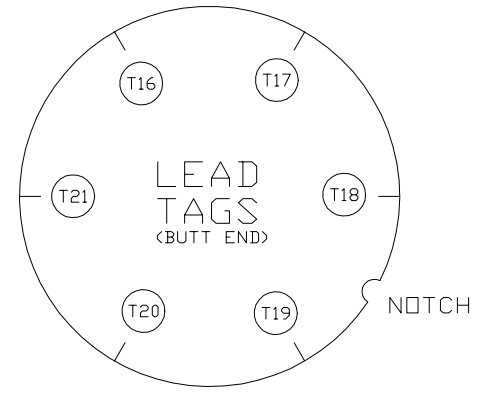
10 Lead Generator Procedure, Reference Connection Diagram 14002-50:

Check resistance from T10-T4. It should be some small number. Then check from T4-T16. It should be a little bit smaller or about the same if not easily detectable then check T10-T16. This should be almost zero. If T16-T4 is almost zero, swap the lead numbers from T10 and T16. Repeat the procedure for the other six sets of coils and leads. If the reading from T4-T16 is nearly equal to T4-T10, the internal connection between coil one and four is wrong. It must be broken and corrected. Repeat the procedure for the other six sets of coils and leads.
